Client: [Rosneft](#)

NL CAMERA DOMINATES COMPARATIVE ANALYSIS

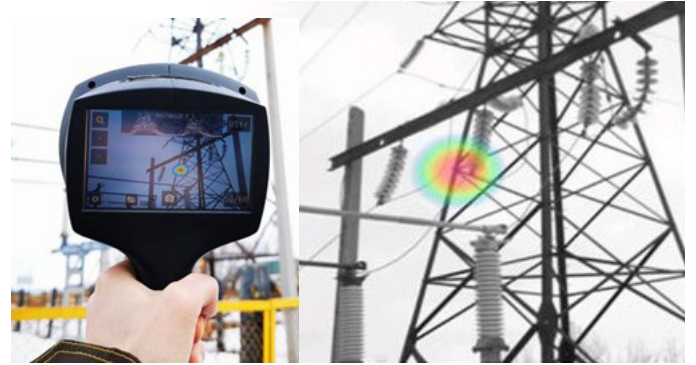
The UV camera also missed a partial discharge at one of the insulators in the garland of insulators VL 110 kV due to sporadic activity. In other words, the partial discharge kept disappearing from the UV camera's sight. Thanks to the longer time in the signal integration, the NL Camera identified the partial discharge.

Image 1. The NL Camera found a surface discharge on one of the insulators in the garland of insulators VL 110 kV. The partial discharge was missed by the infrared and UV cameras.
